Vauxhall CDTI SAAB TID Alfa Romeo MultiJet Inlet Manifold Swirl Flap Rod Replacement 1.9 150BHP Diesel Fix Install Fitment Instructions

by **x8ritd** on November 6, 2014

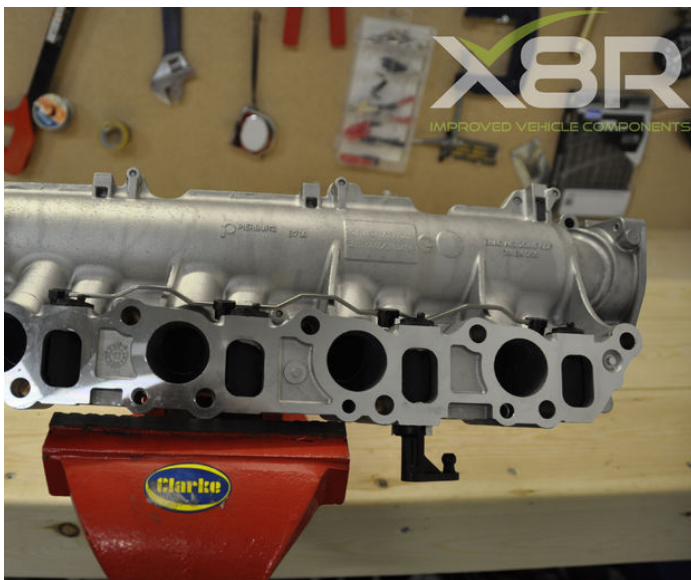
Step 1: Locate loose operating rod

All these symptoms can be caused by the swirl flap operating rod bushes wearing making the operating rod pop off stopping the swirl flaps from operating, you will often see the rod lying on top of the intake manifold.

Locate loose operating rod, you will likely find this laying on top of the manifold. If still in position you can bend a coat hanger to make a hook to aid in removing the rod.

Please note there is no need to remove the manifold for this repair, this repair can easily be carried out in situ. Remove engine cosmetic plastic cover, beneath this you will see the intake manifold.
