## VW Audi Seat Skoda Air Conditioning Compressor Pump Clutch Hub Plate Disc 5N0820803, 5N0820803A, 5N0820803E, 5K0820803A Repair Fix Kit Instructions Install Guide

### **Intro:** VW Audi Seat Skoda Air Conditioning Compressor Pump Clutch Hub Plate Disc 5N0820803, 5N0820803A, 5N0820803E, 5K0820803A Repair Fix Kit Instructions Install Guide

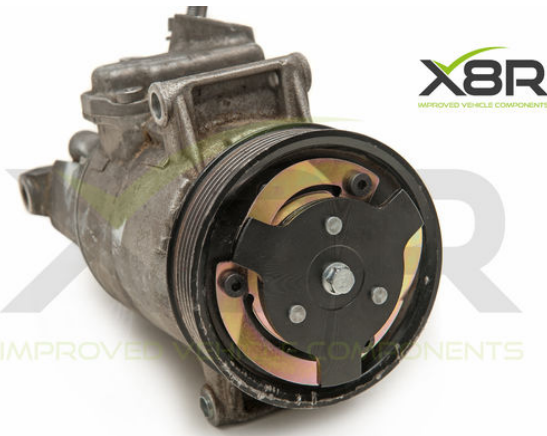
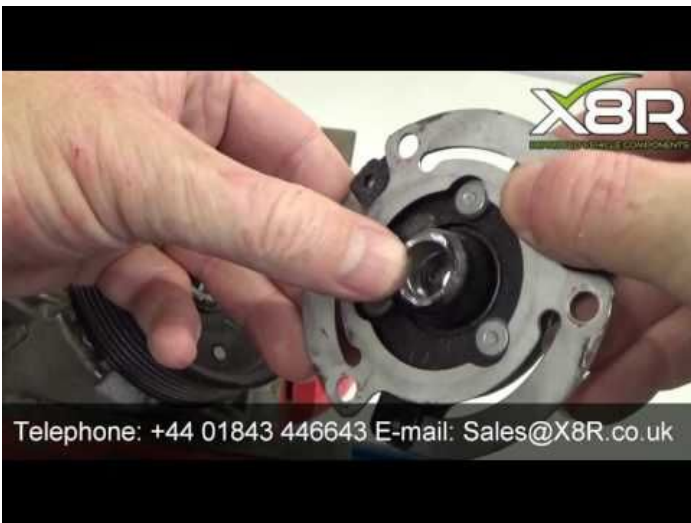
It is a common fault on these air conditioning compressors for the bolt on the shear plate to loosen, causing the splines within the shear plate to wear leading to loss of air conditioning.

These air conditioning compressor pumps all suffer the same common fault. The bolt which retains the shear plate (attached to the drive pulley) to the pump shaft loosens over time. If spotted early the bolt can be seen unwinding itself, eventually it loosens completely and is lost. The pulley will continue to spin with the engine causing the splines within the shear plate to strip. Once this happens the air conditioning pump will no longer function and produce cold air as the pulley can no longer drive the pump. Previously the only solution was to replace the complete compressor at vast expense. We now provide just the shear plate and bolts so you can repair your compressor and restore the A/C at a fraction of the price.

Fit our replacement shear plate and bolts and restore your air conditioning compressor to full output.

Our replacement shear plate is a direct replacement for the damaged OEM part. Simply remove the old shear plate and replace with ours, this can normally be done in situ (please check out our video and instructions for guidance) and restore full function to your air conditioning. We also include 4x replacement bolts so all components are included to restore cold air. Providing a massive saving over replacing the complete compressor. A very common fault resolved by our repair kit.

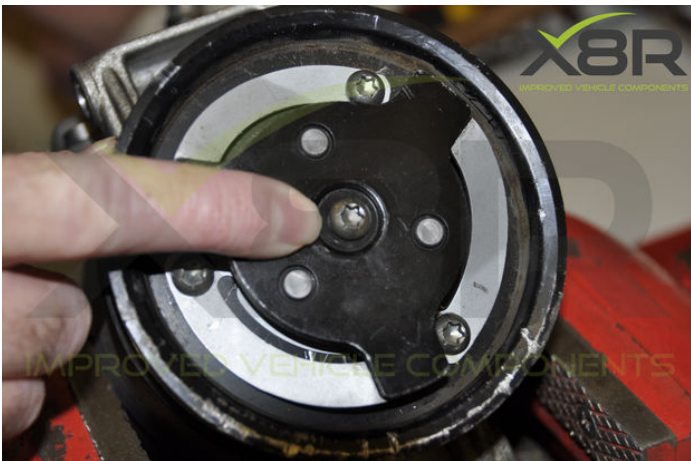
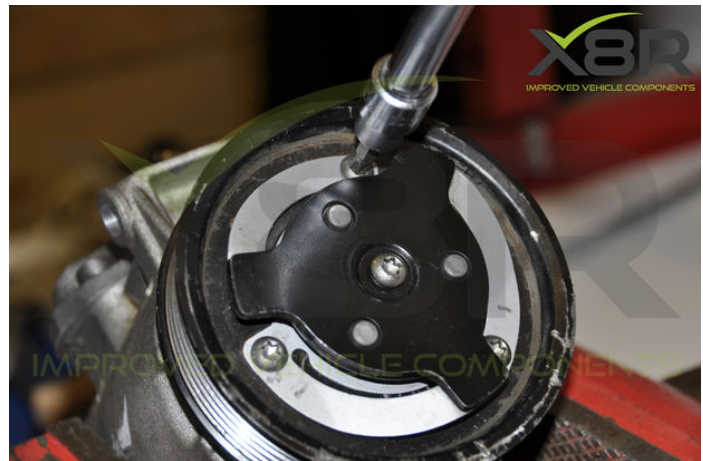
### Step 1: Remove 4x shear plate bolts

Using a T30 Torx bit remove the Four bolts holding the shear plate to the drive pulley.

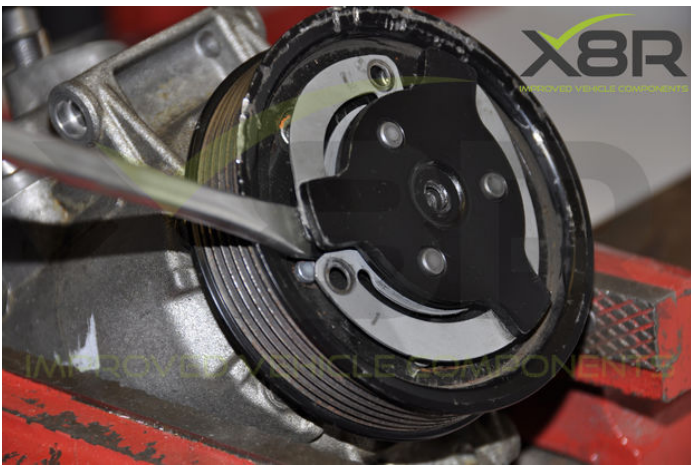
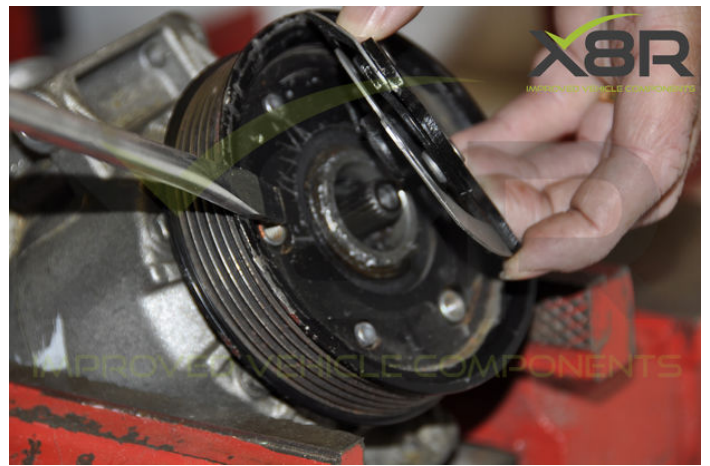
### Step 2: Prise off the shear plate

Using a large flat bladed screw driver lever between the shear plate and the pulley to prise off the shear plate.

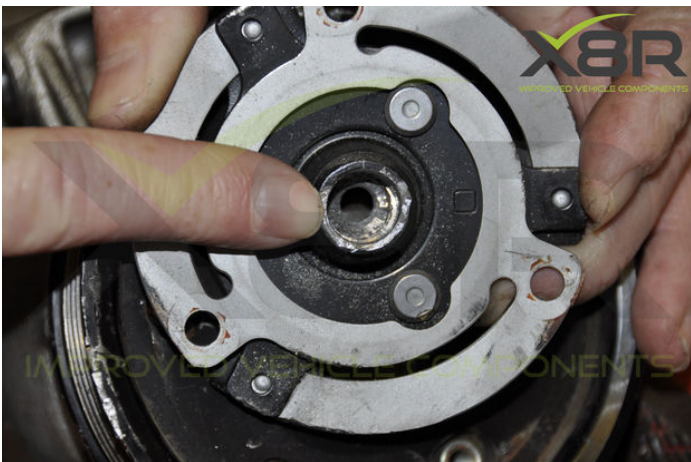
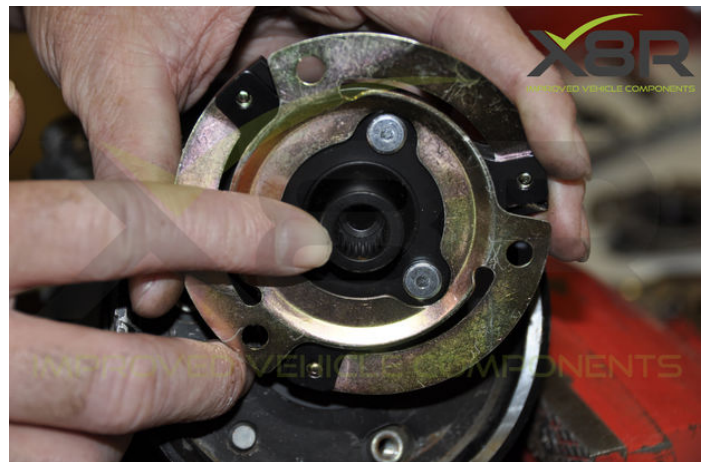
### Step 3: Shear plate damage

Here you can see the damage to the shear plate caused by the retaining bolt loosening, the splines have been damaged leading to the shear plate no longer engaging with the compressor pump splines.

You can see here our replacement shear plate with the splines in good condition.

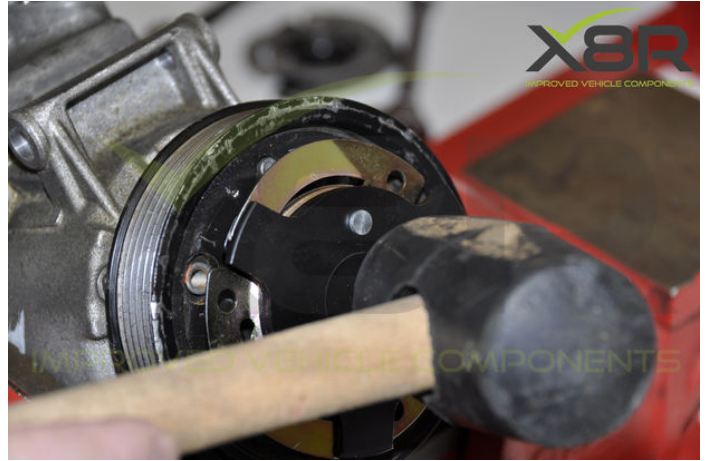
#### Step 4: Push fit our new shear plate

Push our shear plate on to the pump splines.

Gently tap the shear plate with a rubber mallet to engage the splines, just enough so our bolts can be fitted to draw in the splines fully.

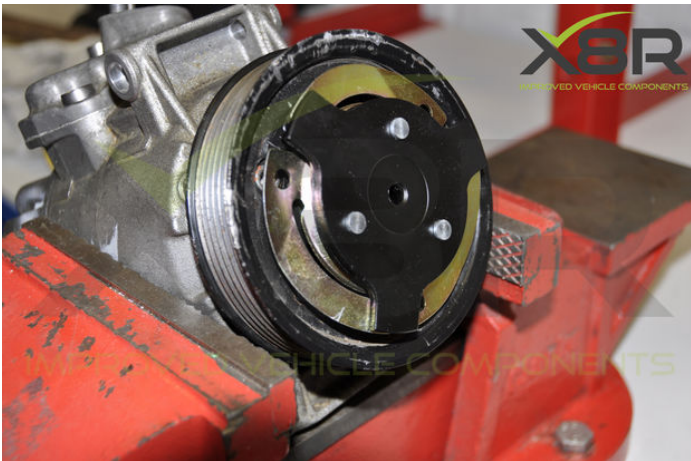
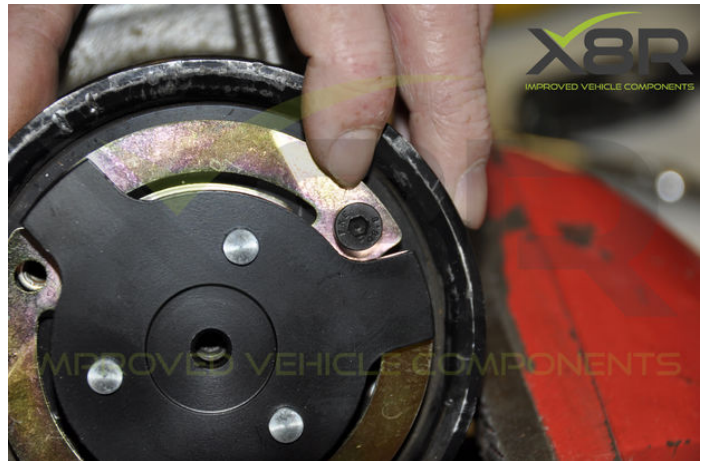
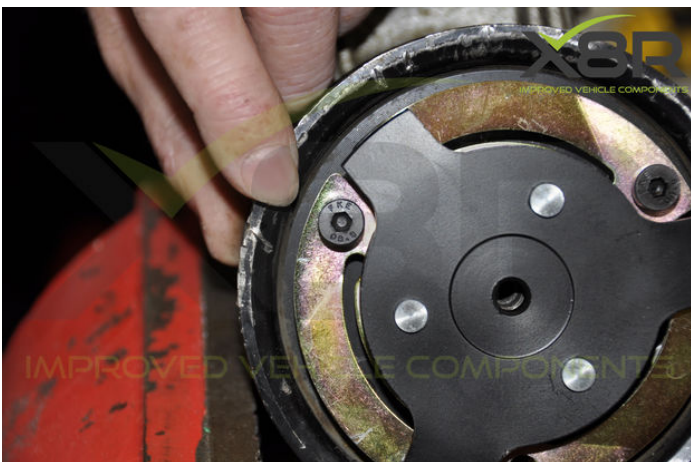
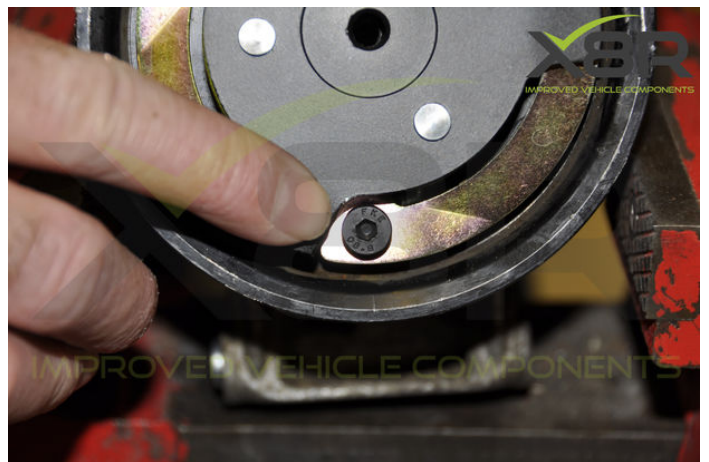
#### Step 5: Fit our replacement bolts

Fit our replacement bolts and tighten fully, this will pull the shear plate in to position and fully engage with the pump splines.

We recommend applying a thread locking compound to the bolts.

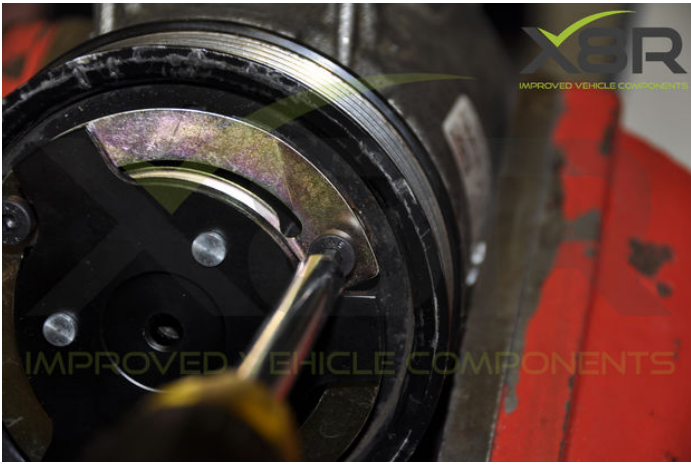
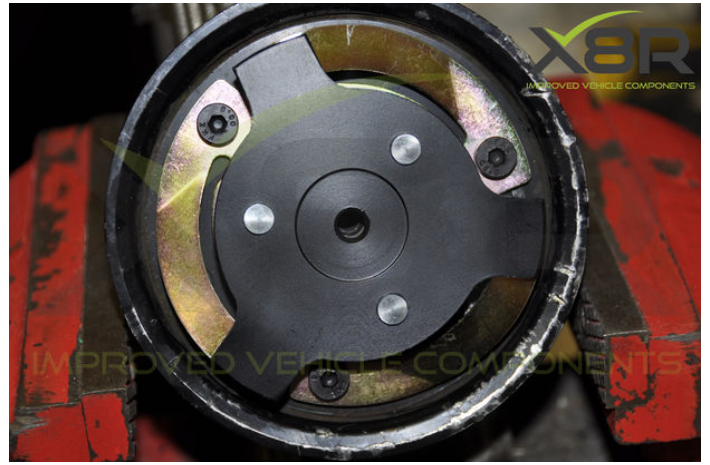
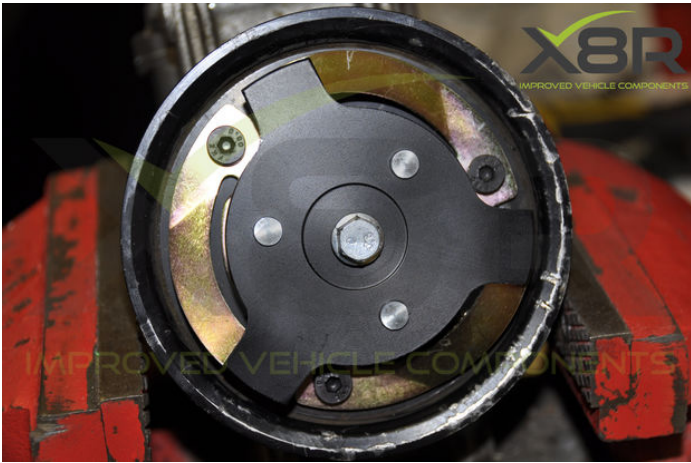
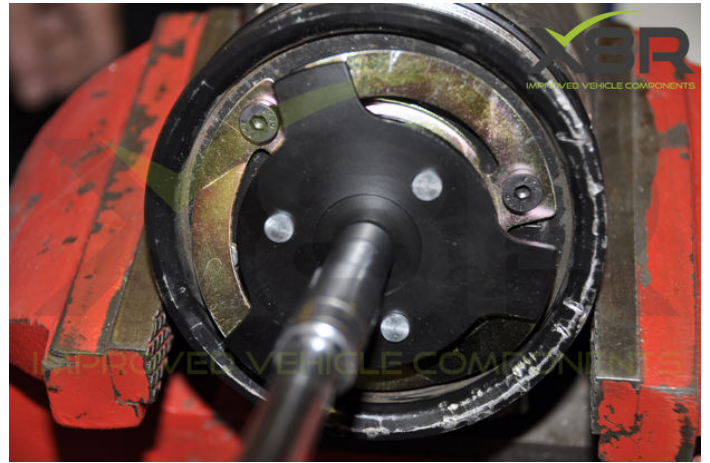
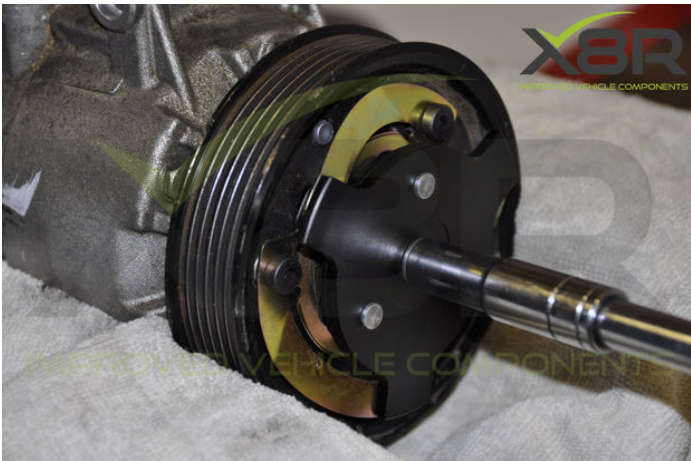
### Step 6: Check repair

This completes the repair. We recommend periodically checking the shear plate bolts for tightness.
