# Renault Sport RS Clio II Mk 2 172 182 Steering Wheel Rubber Replacement Thumb Grips Install Instructions Fitting Guide

## **Intro:** Renault Sport RS Clio II Mk 2 172 182 Steering Wheel Rubber Replacement Thumb Grips Install Instructions Fitting Guide

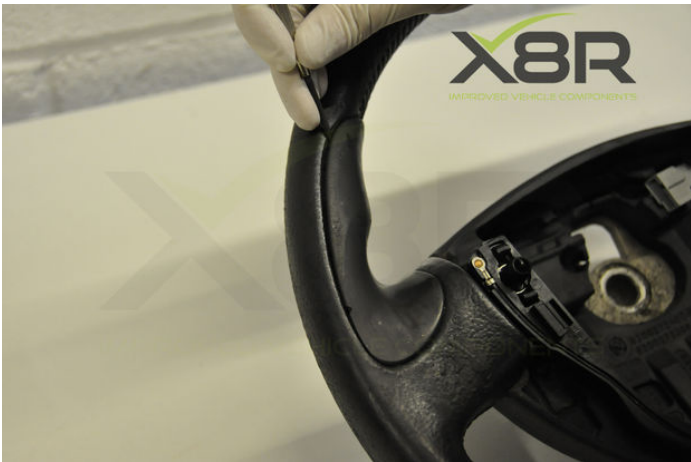
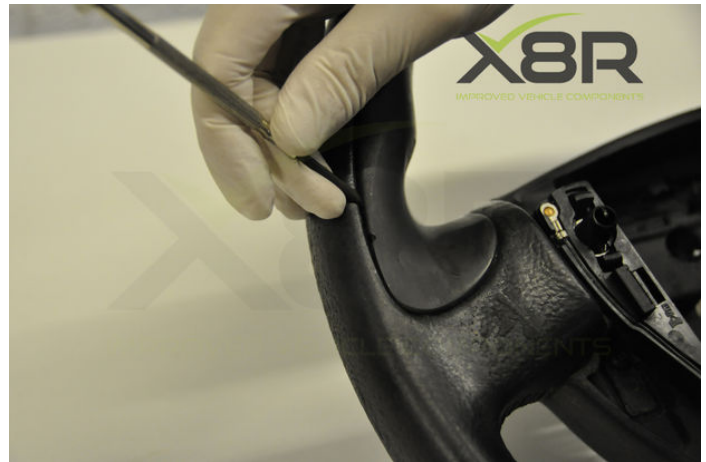
### Step 1: Remove the old thumb grip

- Start by removing the old thumb grip from the steering wheel using a small flat bladed screw driver or pick.
- Slot the pick or screw driver in the gap between the thumb grip and the steering wheel, taking care not to damage the steering wheel.
- Pry back the remains of the original thumb grip until it starts to lift, then work your way around the grip and remove it slowly.

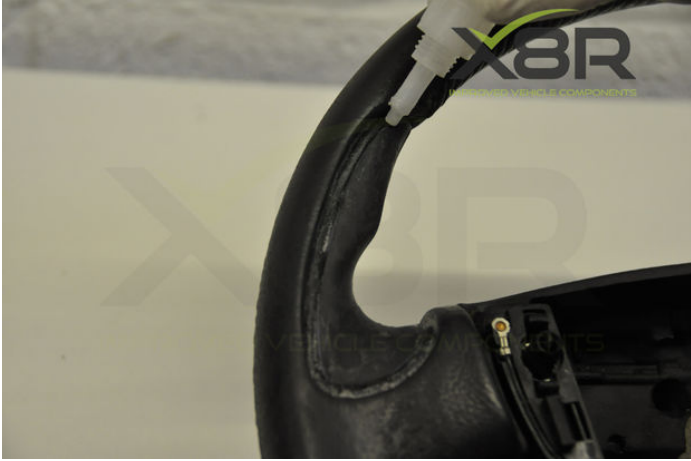
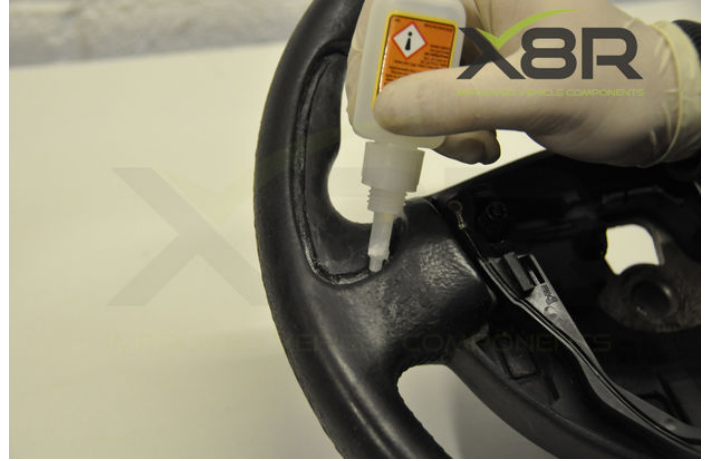
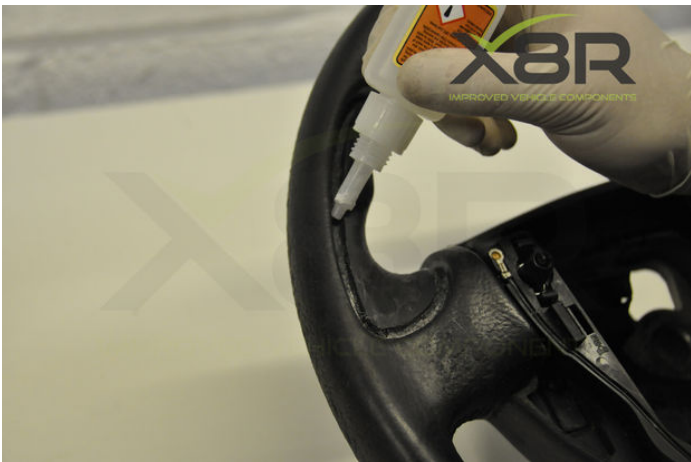
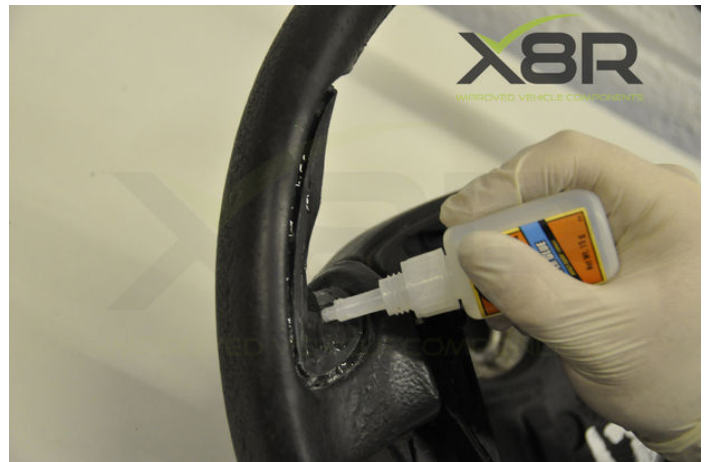
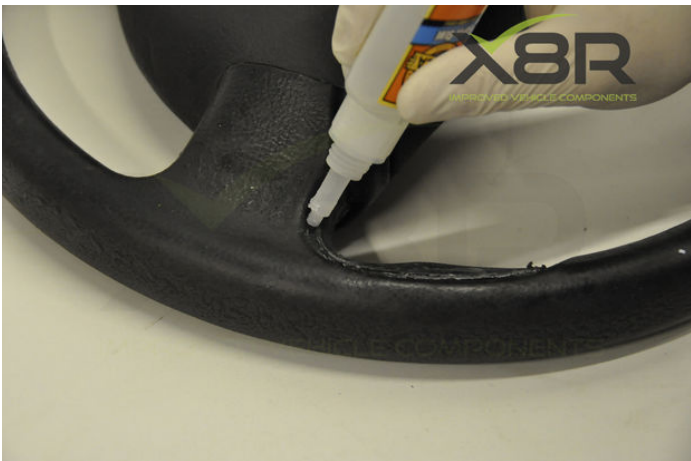
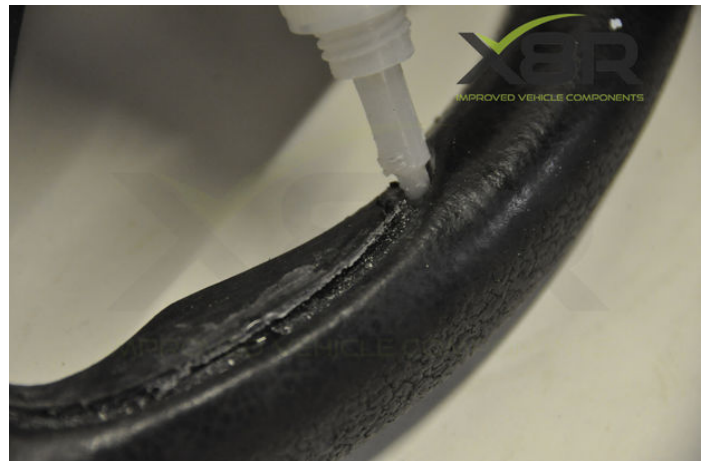
### Step 3: Apply glue

- Apply glue in the groove of the steering wheel, running the glue all the way around the groove and the center part of where the grip sits (as shown in the images) - making sure to keep away from the leather part of the steering wheel.

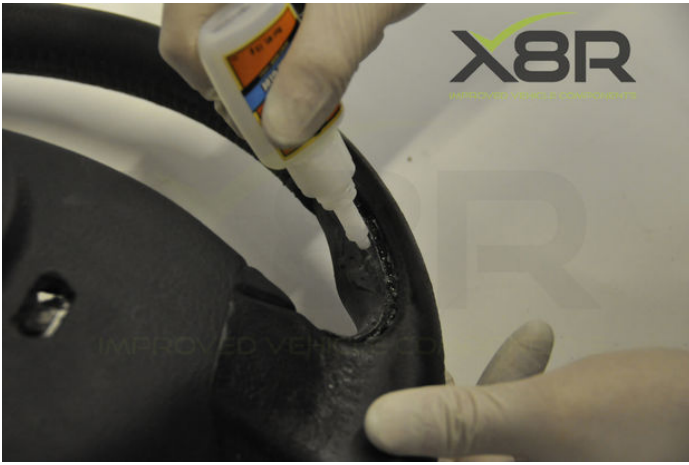
#### Step 4: Fit the new grip

- Offer up the new grip to the steering wheel
- Make sure the thumb grip is sitting correctly on the front and back
- Once you're happy with the way it's seated on the steering wheel, hold in place for up to 30 seconds to allow the glue to set.
- Repeat this process for the second grip.
