# Volkswagen VW New Beetle Golf Mk4 Jetta Bora 1J Glove Box Not Latching Dropping Down Lid Repair Fix Kit Instruction Install Guide

## **Intro: Volkswagen VW New Beetle Golf Mk4 Jetta Bora 1J Glove Box Not Latching Dropping Down Lid Repair Fix Kit Instruction Install Guide**

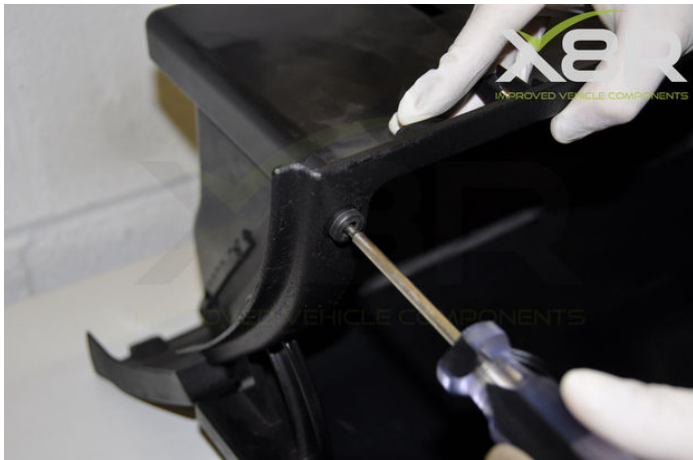
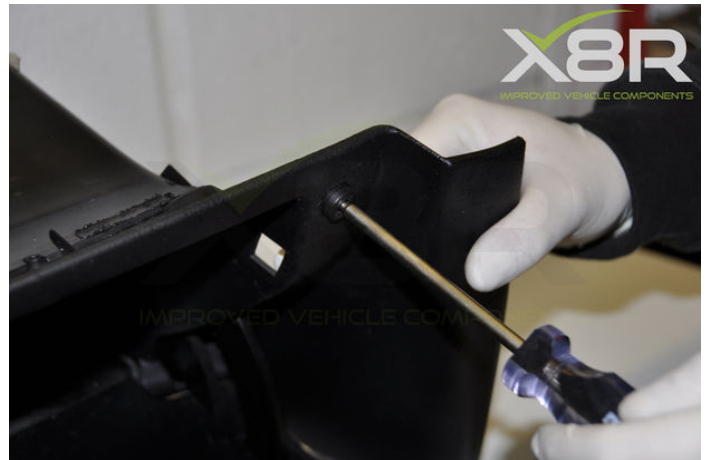
### Step 1: Remove the lid stoppers

- Using a T20 Torx screw driver remove both of the glove box lid stoppers.
- The Torx screws are located in the center of the stopper

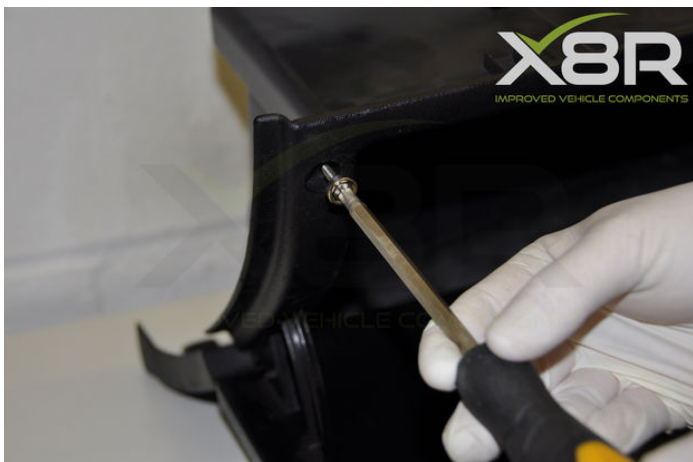
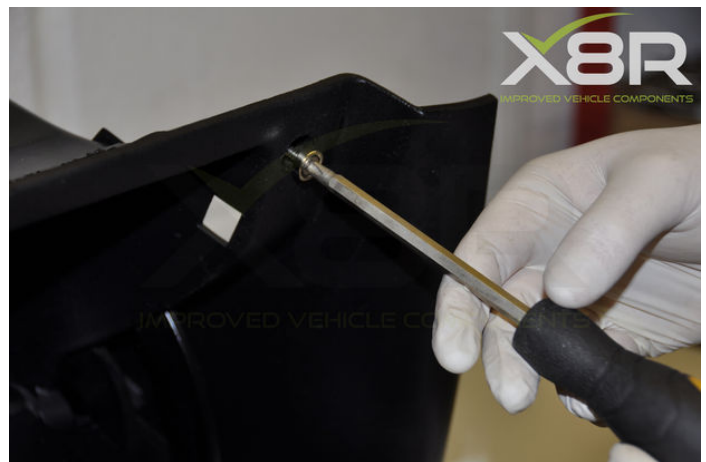
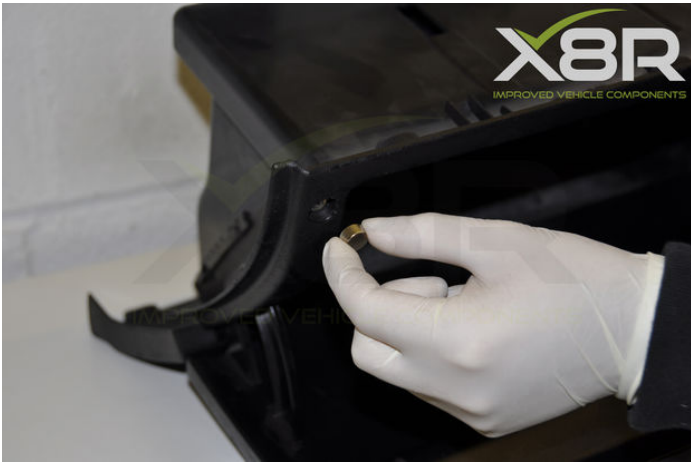
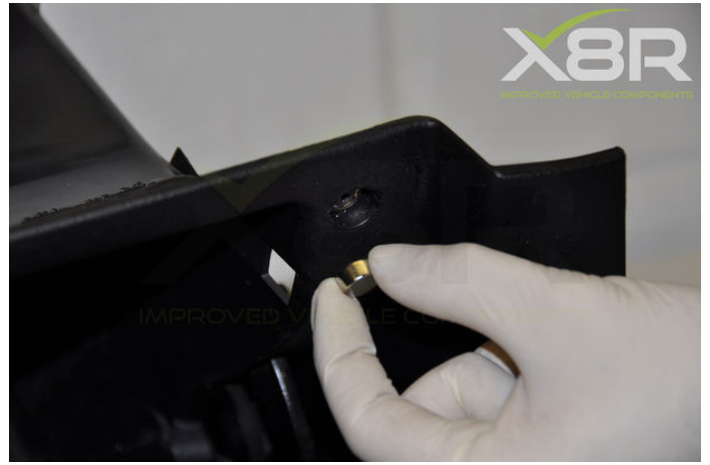
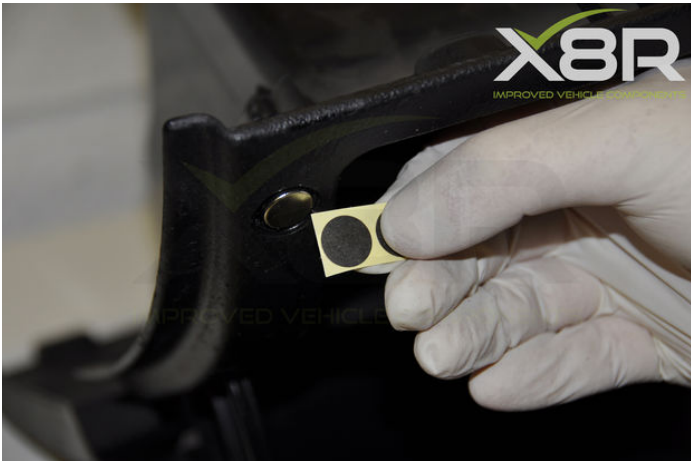
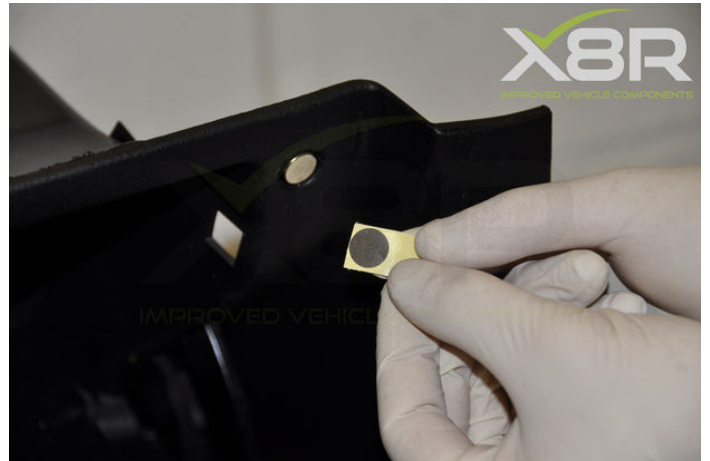
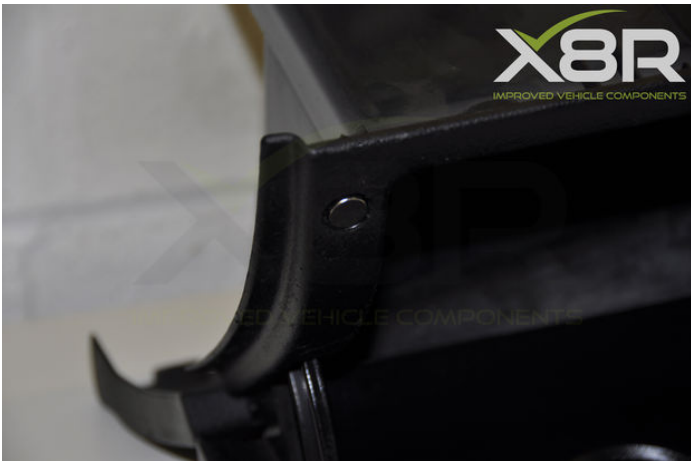
### Step 2: Fit the countersunk screw and magnets in place of the stopper

- Replace the parts you just removed with the silver Philips countersunk screw and countersunk magnet supplied in our kit.
- When fitting the countersunk screw it's not necessary to tighten the screws too tight as this will damage the magnet - gently nip the screw up.
- With the countersunk screw and magnet in place its time to fit the larger magnet, push in the recess, this will locate its self.
- There are 2 black magnet covers supplied within your kit if you wish to fit these for aesthetics reasons only.

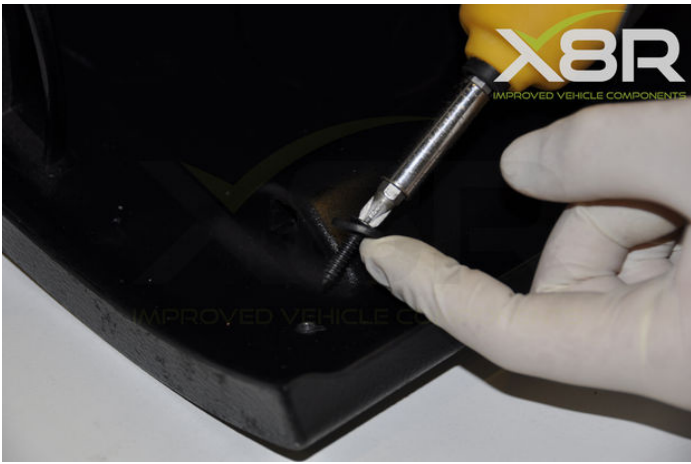
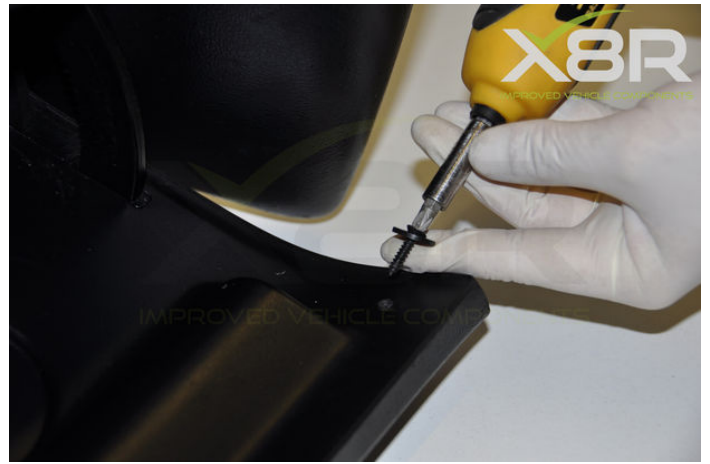
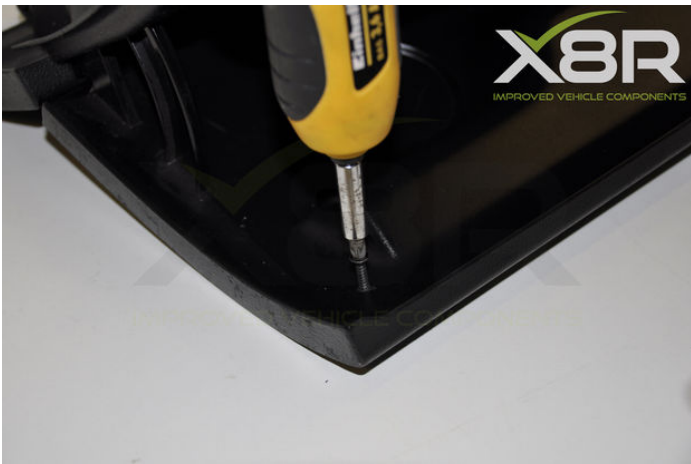
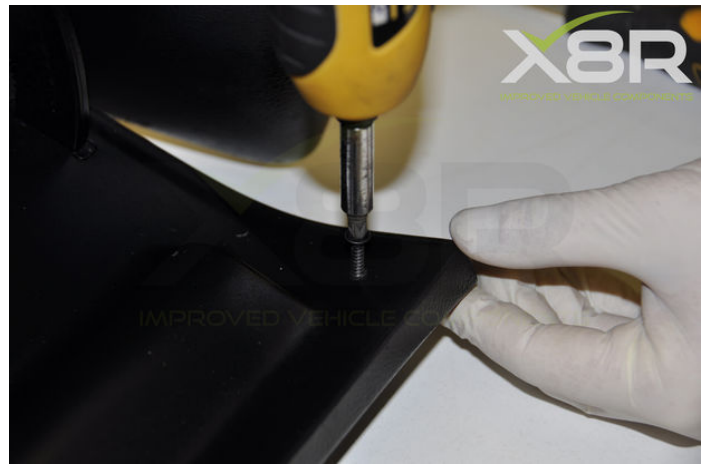
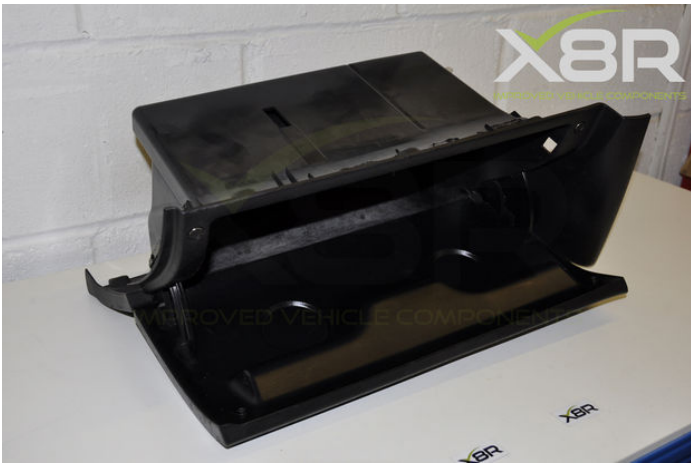
### Step 3: Fit the black countersunk screw and washer to the lid

- Located on the inside of the glove box lid, you will see two marks - one on either side from the lid rubbing on the stoppers over time.
- Align the screw to the center of that mark and screw in place.
- Try to fit the screw as central as possible.
- Once you have the hole tapped remove the screw and fit it with the washer on both sides.
- You can now test the lid, it will retain tightly on the magnets and restore function to your glove box lid.
