# Universal Bosch Common Rail CP1 High Pressure Fuel Pump O-Rings Seal Seals Repair Fix Kit Leaks Instructions Install Guide

by **x8rltd** on February 25, 2016

### **The Problem**

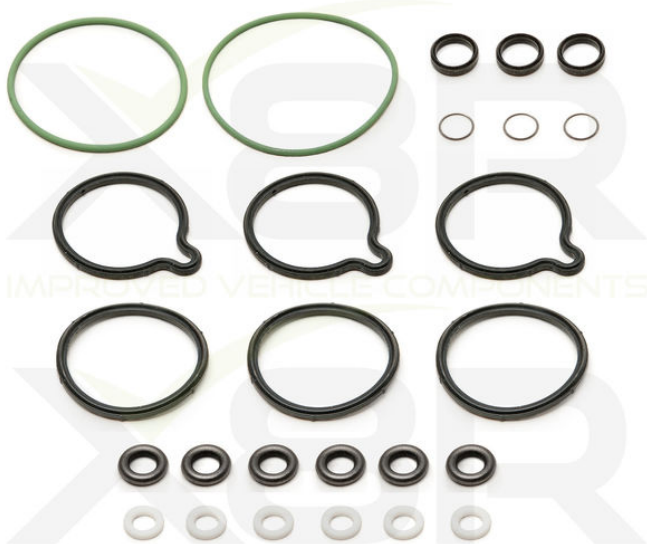
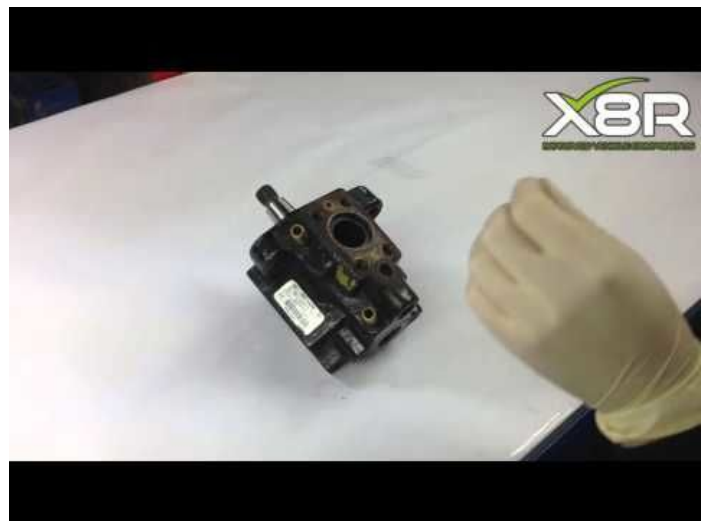
Our repair kit includes replacement seals for those that commonly fail within the CP1 fuel pump causing fuel leaks. Our unique kit includes both type of head seals for these pumps both the circular and shaped seal. Our kit allows you to replace just the seals /gaskets / O-rings which fail without the need to replace the complete pump at vast expense. Our kit includes the seals that commonly fail including the head seals, conical seals, fuel galley seals and drive shaft seals. Designed to enable you to repair your current unit at the fraction of the price of a new or reconditioned unit.

3x Head seal (round)  
3x Head seal (shaped)  
3x Conical seal  
6x Fuel galley nylon rings  
6x Fuel galley O-ring seals  
2x Drive shaft orings  
3x Small head seals

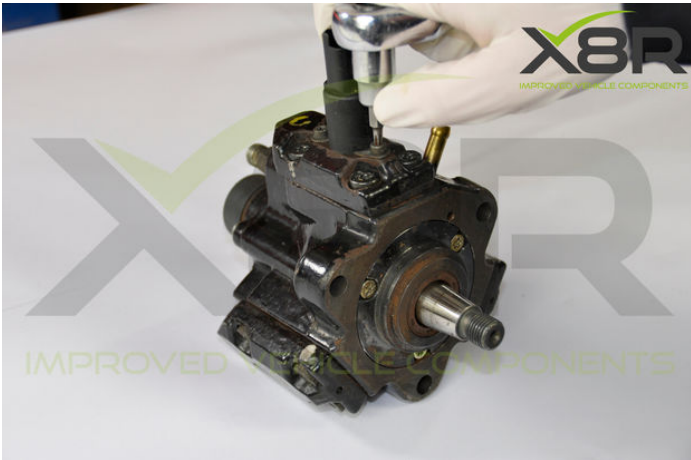
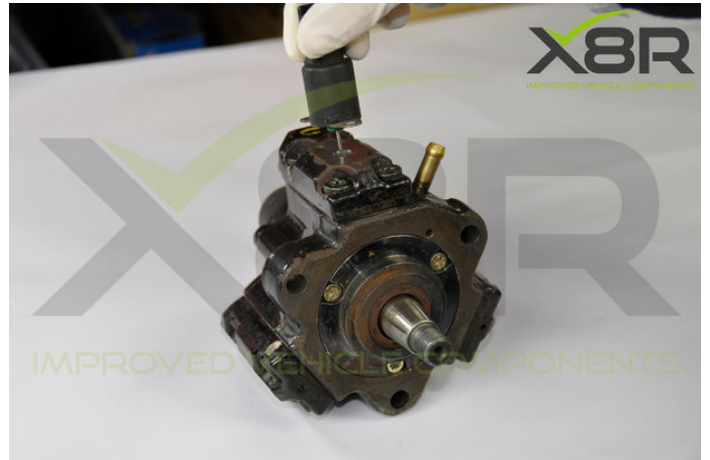
### Step 2: Remove the 3rd valve solenoid / pressure regulator

- Remove the 3rd valve solenoid and pressure reg from the pump.
- Remove the three T20 Torx screws that hold the 3rd valve solenoid to the cylinder head - once all three are removed lift it up, you may have to twist the solenoid to allow the o-ring on the solenoid to release itself from the pump.
- Remove the two T30 Torxs that hold on the pressure reg and lift up, there will be a gasket which also needs to be removed.

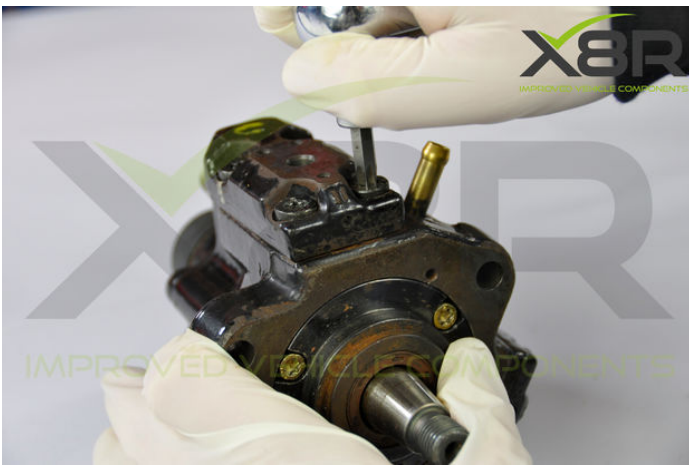
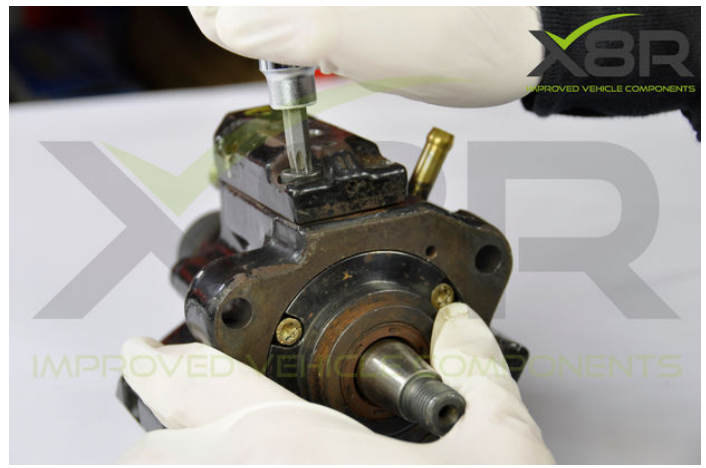
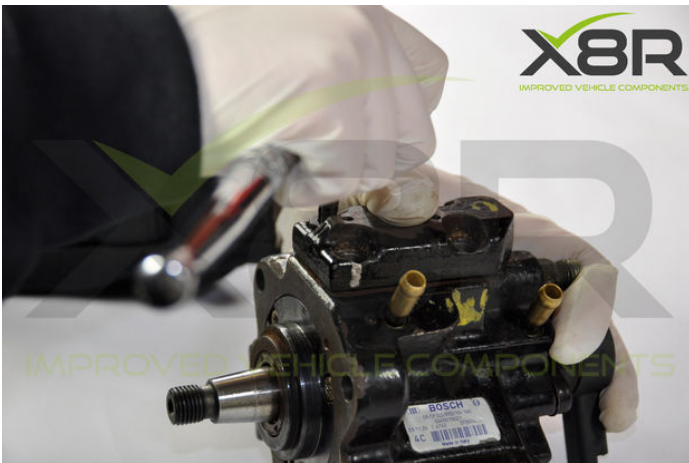
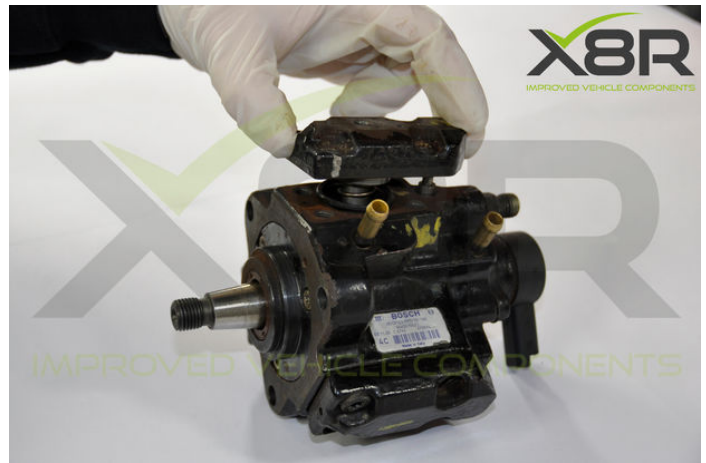
### Step 3: Remove the three cylinder heads

- We recommend that you repair the seals in each head one at a time.
- Remove the four T40 Torxs from the cylinder head - on undoing the last T40 Torx press down on the cover as the cylinder head will start to lift due to a spring below the head (it can lift with force, so be careful once unbolted).
- Repeat for all 3 cylinder heads. It is advised to label each cylinder head for re-fitting purposes.

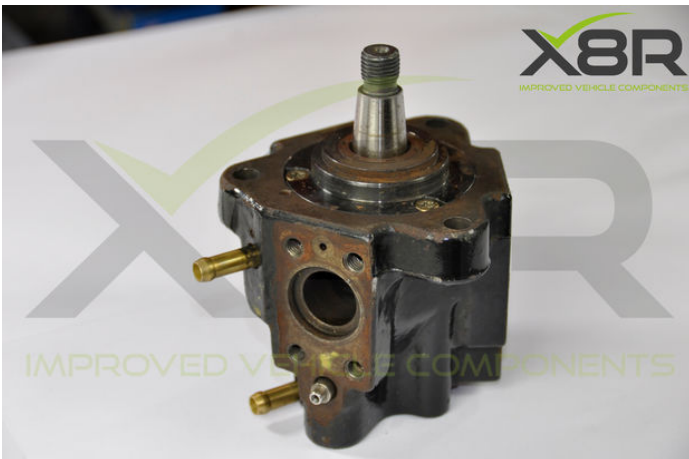
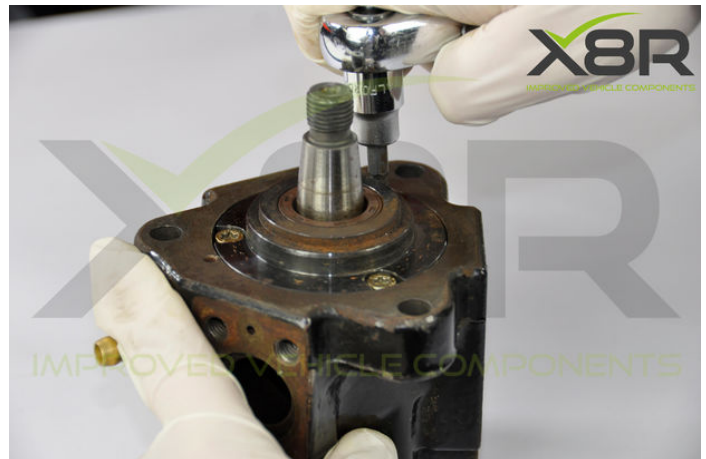
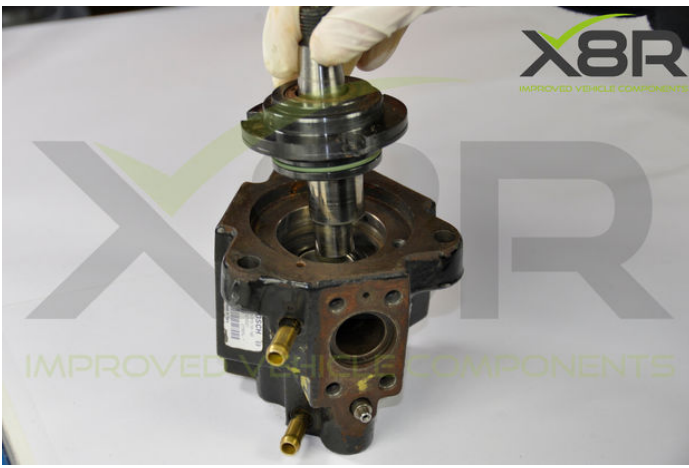
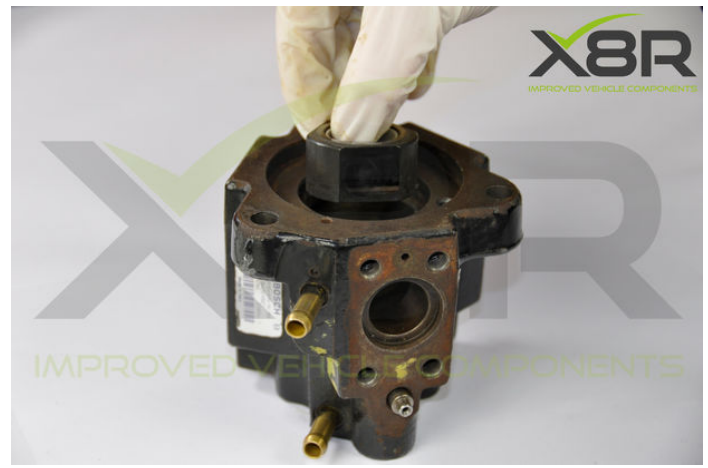
#### Step 4: Remove the drive shaft

- Remove the three T30 Torxs to allow removal of the drive shaft.
- With the three bolts removed the drive shaft will lift up (some may need a little tap to allow the o-ring within the pump to release)
- With the drive shaft removed there is drive shaft cam on the inside of the pump which will just lift out freely.

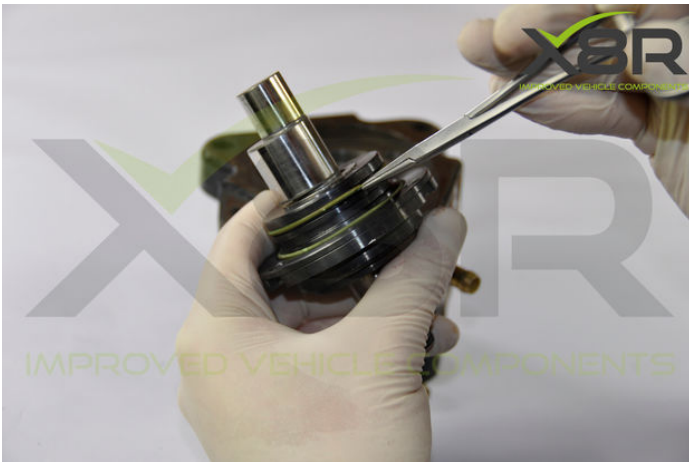
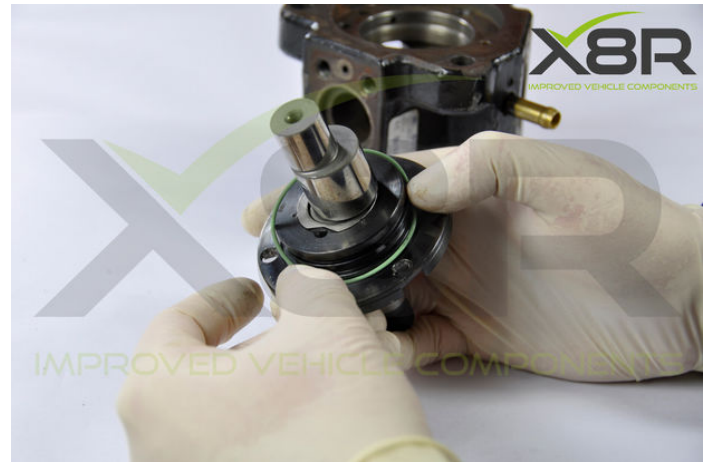
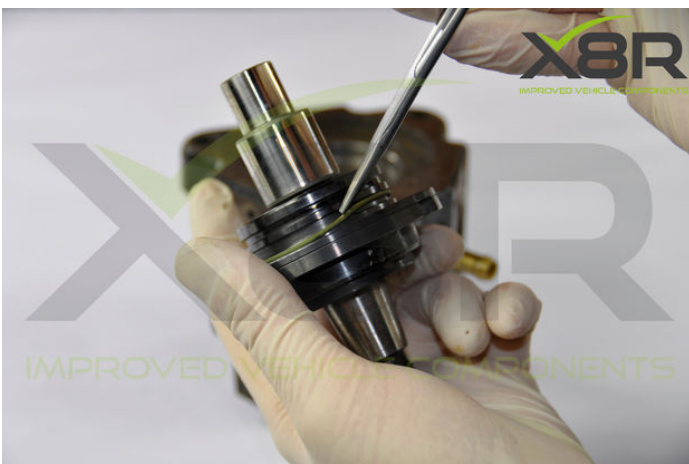
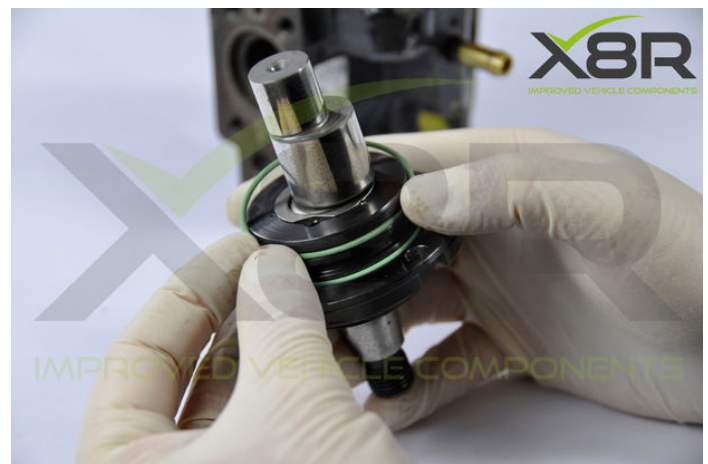
### Step 5: Replace the drive shaft o-rings

- There are two o-rings that need replacing on the drive shaft, which are of two different sizes.
- To remove the o-rings, you could use a small pick or a small pair of pliers.
- Remove the two o rings from the drive shaft as shown.
- Slide the new o-rings on to the drive shaft and slot into the correct position slots, making sure the O-rings are seated correctly.

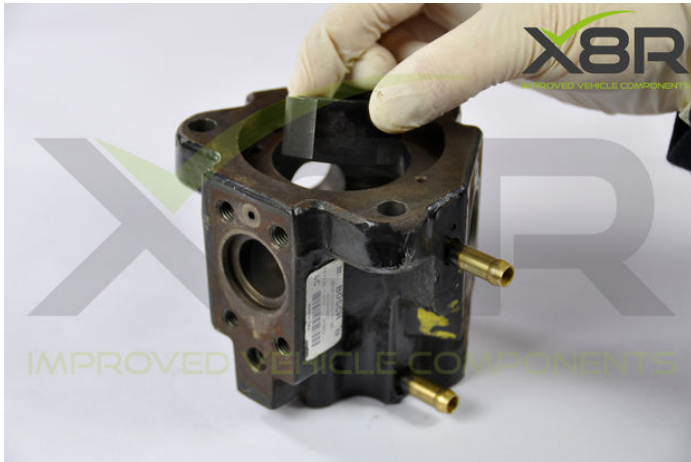
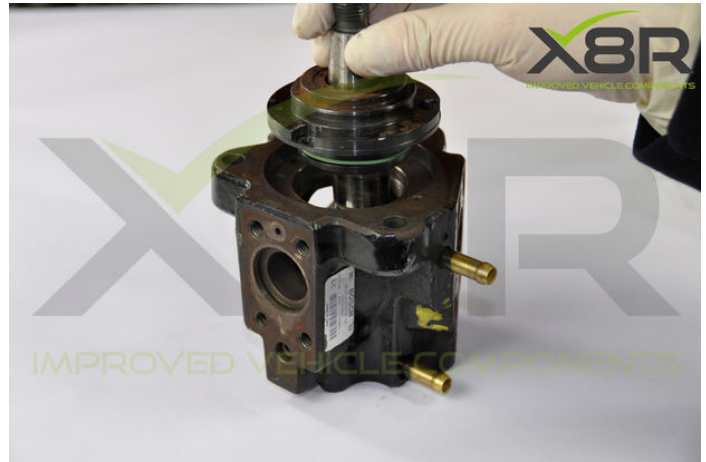
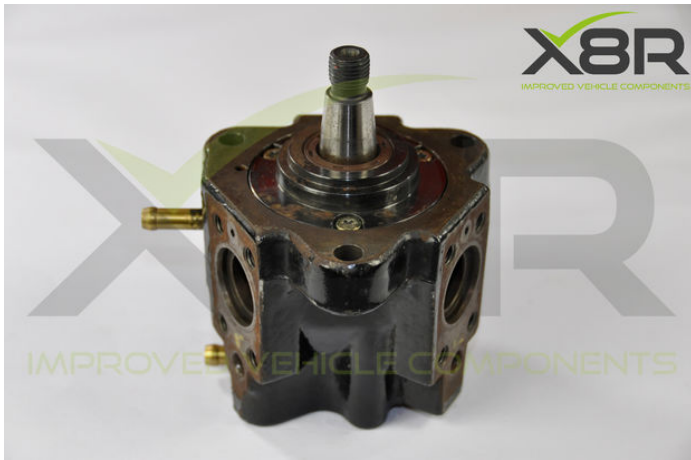
### Step 6: Refit the drive shaft and cam

- Re-fit the drive shaft cam into the pump.
- Slot the drive shaft into the pump, when fitting the drive shaft line up the bolt holes in the correct position.
- Re-fit the three T30 Torxs.

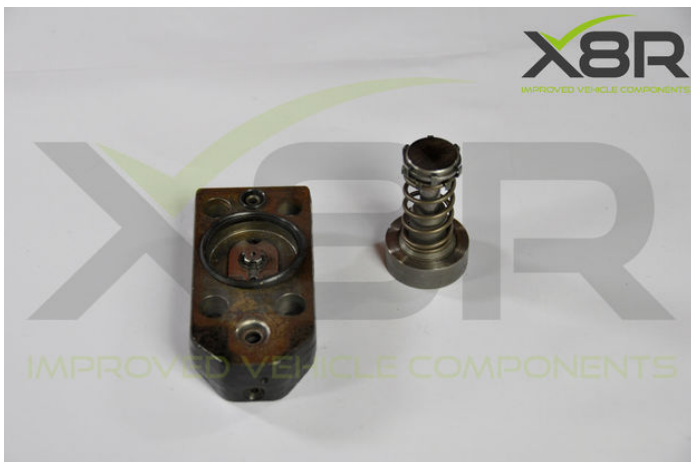
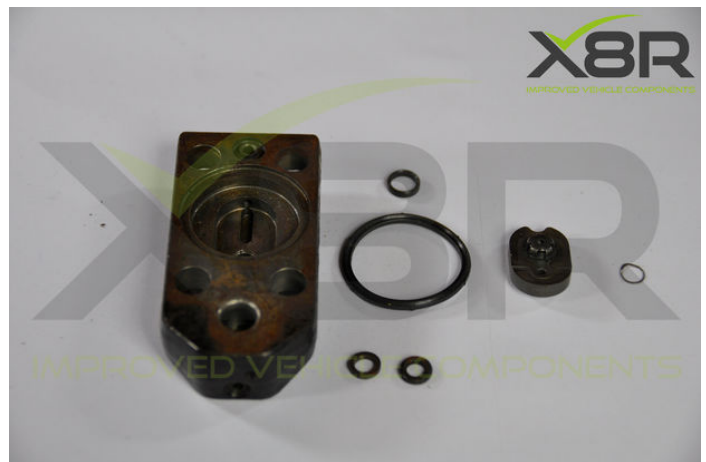
### Step 7: Remove the seals / orings on the cylinder head

- Using small pick or a small pair of pliers to remove the o-rings/ seals from the cylinder head.
- The plunger spring and valve cage may just lift out as one.
- If they don't come out as one, lift the plunger spring out, which will then allow access and removal of the valve cage - now you'll have access to the metal o-ring.
- Using a pick pop out the seal that sits around the plunger spring.
- Ensure all seals are removed from the head.

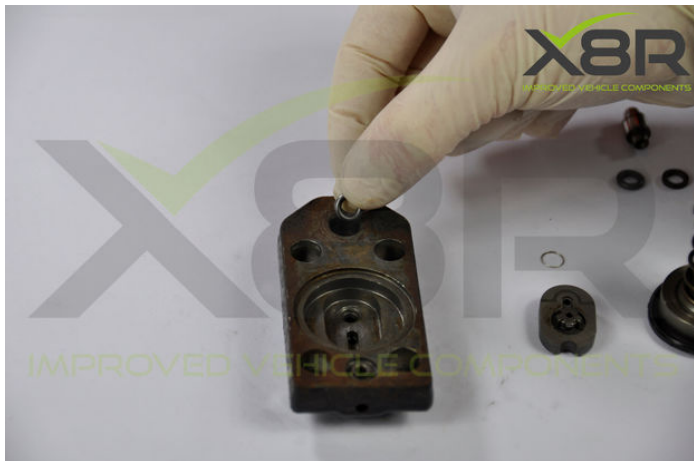
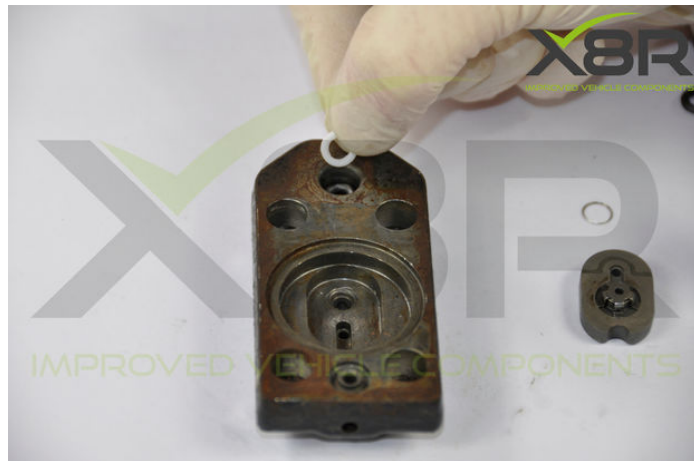
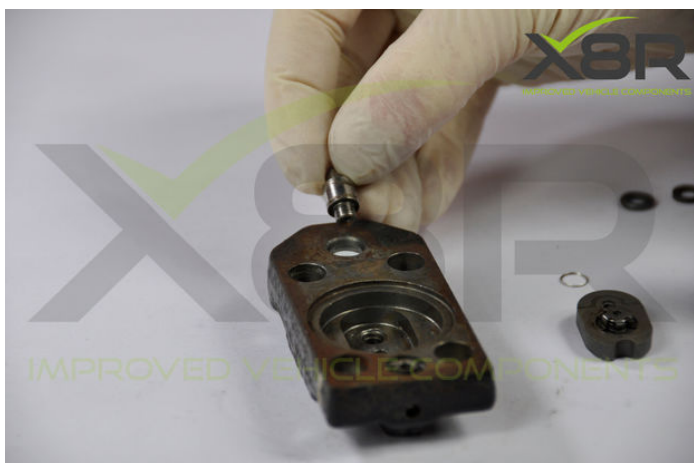
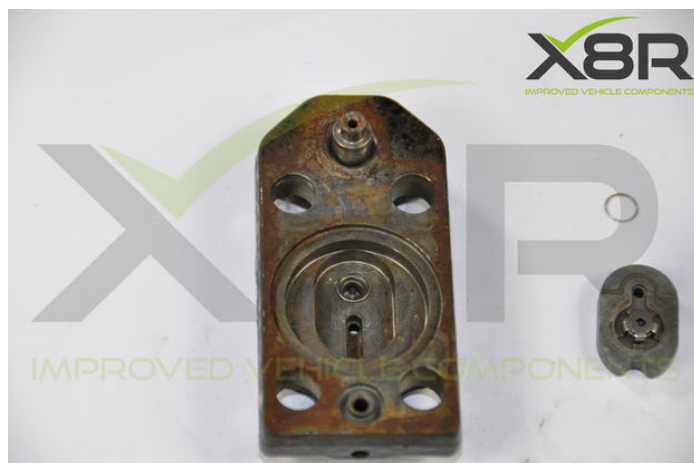
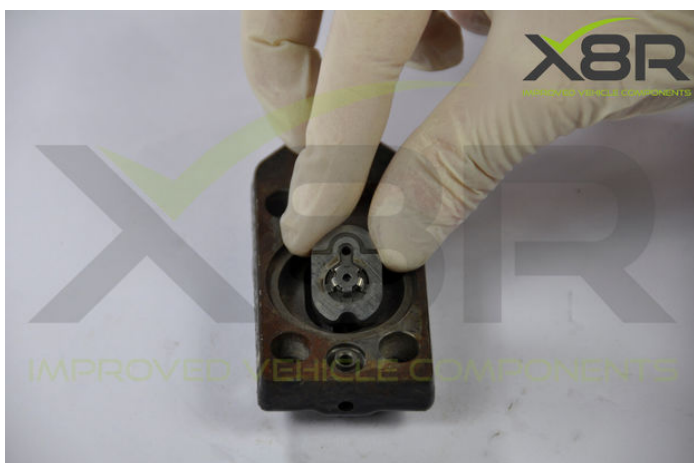
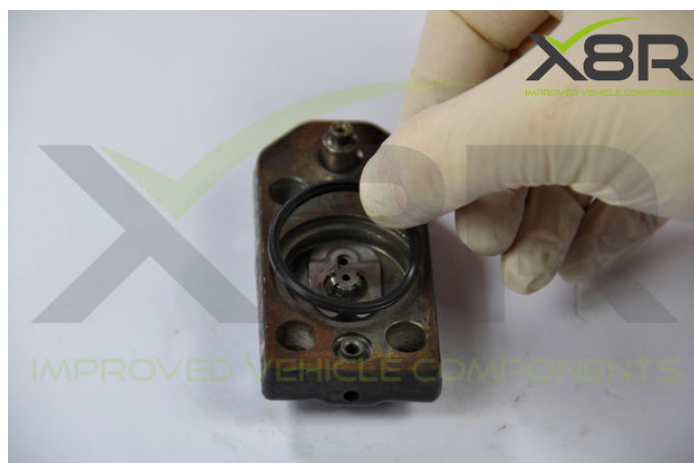
## Step 8: Replace the head seals

- Follow order of pictures:

1. Slot in the rubber o-ring, you may have to press into place.
2. Slot in plastic o-ring again press into place.
3. Re-fit the fuel gallery - press into the plastic o ring.
4. Re-fit small metal washer.
5. Re-fit valve cage.
6. Re-fit new seal around the plunger spring.
7. Re-fit plunger spring.
8. Re-fit small o-ring - this o-ring does need pressing in using a blunt pry tool.

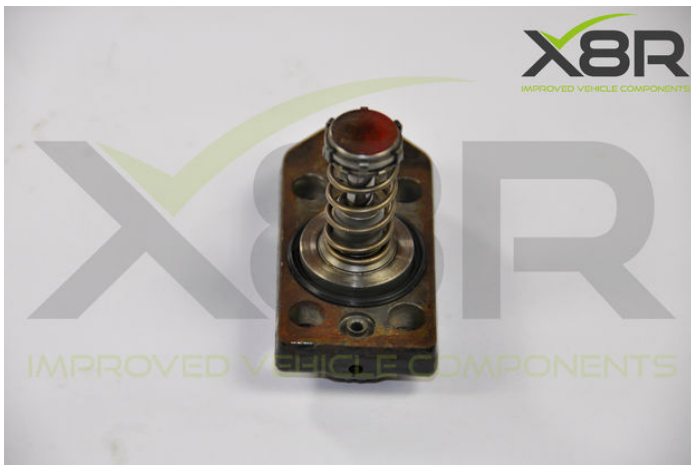
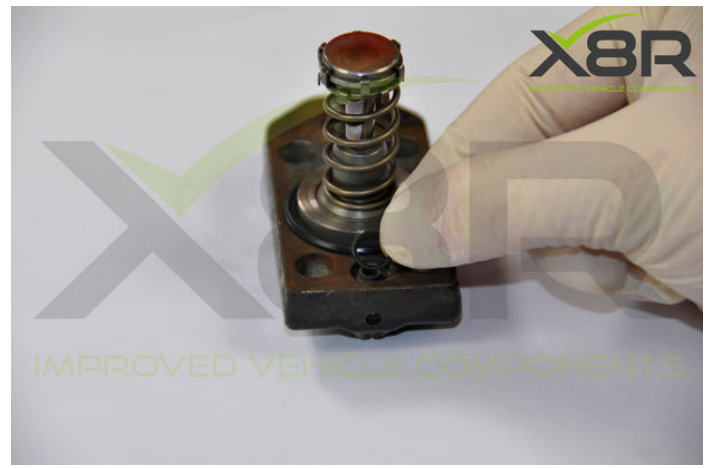
**Step 9: Remove and replace the seals / oring in the pump body**

- Using a pick or small pair of pliers pick out the plastic o-ring, once removed this will expose another rubber o-ring.
- Refit replacement rubber o-ring, you may have to press it into place.
- Refit the plastic o-ring, slot into its groove and press in.

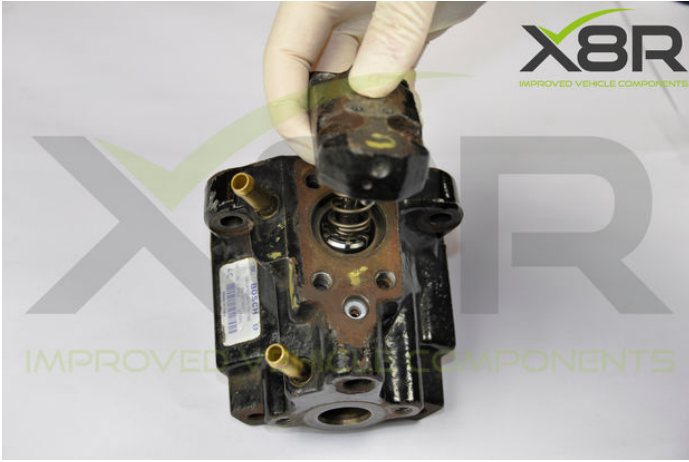
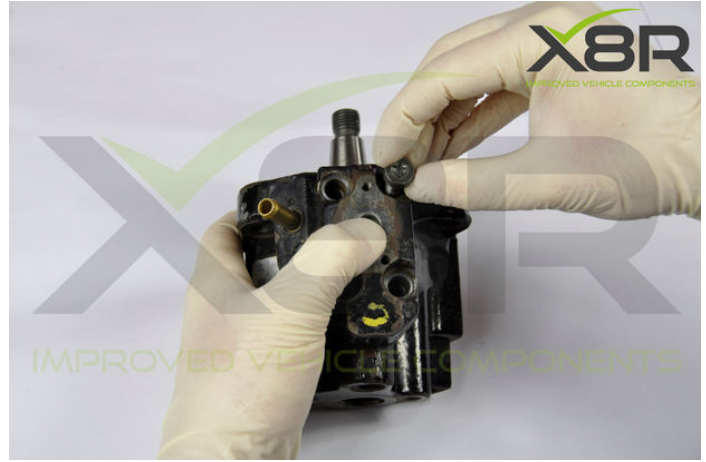
### Step 10: Refit the cylinder head

- Refit the correct cylinder head to pot as labeled in step 2.
- Refit cylinder, fit into the body, making sure the seals stay in the correct position.
- Pressing down the cylinder head refit the four T40 Torxs.
- Repeat for all three cylinder heads.
- Torque setting for cylinder head bolts is 25nm.

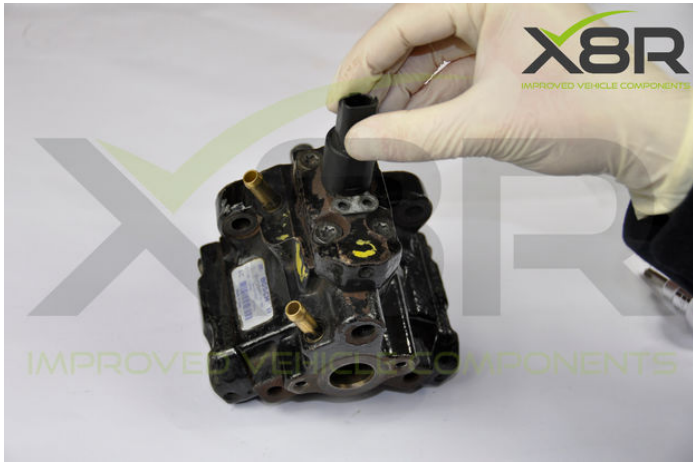
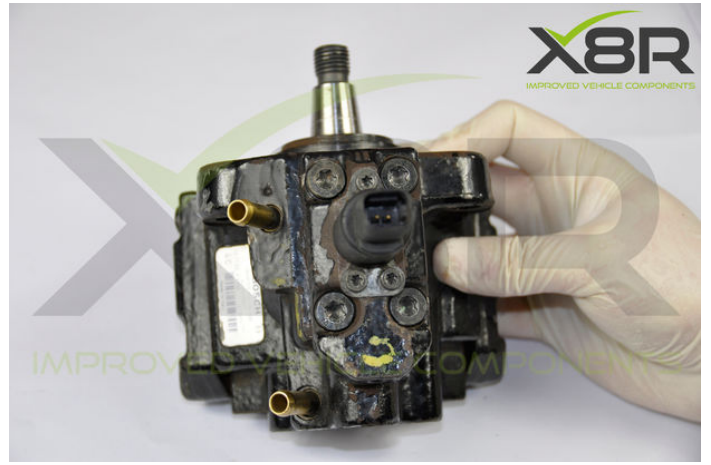
### Step 11: Refit the 3rd valve solenoid / pressure reg

- Refit the solenoid to the cylinder head. Slotting into the cylinder head.
- Refit the three T20 Torxs
- Refit the pressure reg, with the two T30 torxs
