# BMW 6 cylinder dual vanos piston seal repair fix process instructions

### Intro: BMW 6 cylinder dual vanos piston seal repair fix process instructions

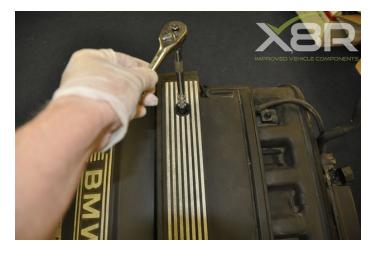
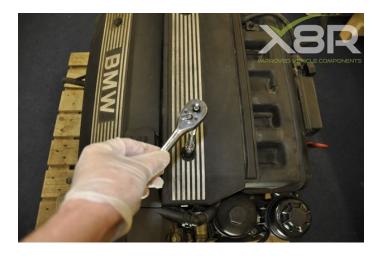
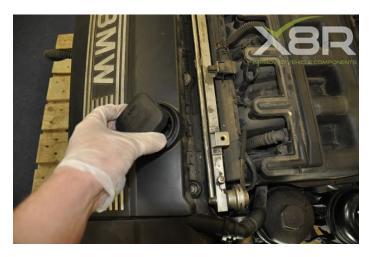
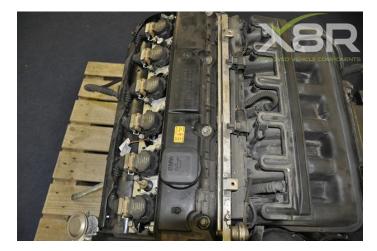
### Step 1: Remove engine covers

- Ensure vehicle is cold and not hot from running when beginning repair.
- Remove cooling fan, cooling fan shroud and cabin filter housing.
- Remove 2x engine covers, pry off 2x caps on each cover, remove 2x 10mm nuts on each cover. Remove Right cover, unscrew oil filler cap remove Left cover and replace oil filler cap.

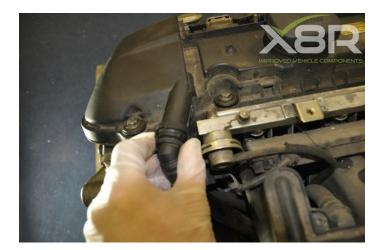
Step 2: Remove valve cover vent hose
Remove valve cover vent hose press in connector top and bottom and wiggle gently loose, the hose from this connector is likely to be very brittle, do not put pressure on the hose; sudden release of the connector will snap the hose, take extreme care.

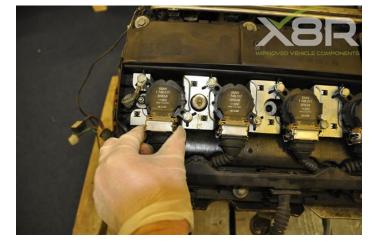
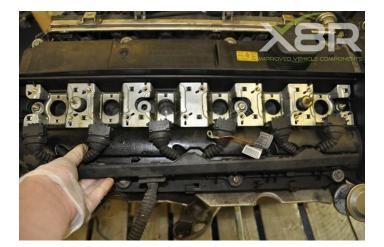
- Step 3: Remove coil harness
  Remove ignition harness, on each coil pull up connectors metal lock mechanism and pull off connector
  Remove coil earth straps at cylinders 1 and 6 using 8mm socket.
  Remove coil harness earth strap located between coil 2&3 using 8mm socket
  Remove coil harness from valve cover, pry on clips and move out of way

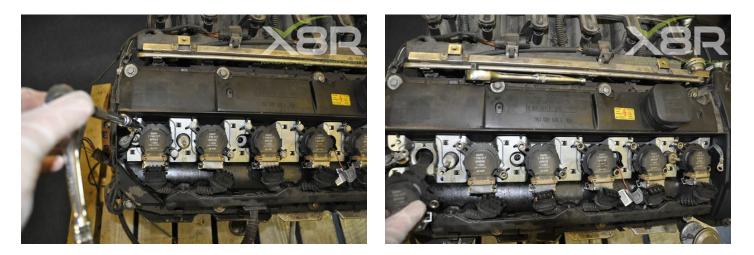
# Step 4: Remove coils

- Remove coils unscrew two bolts on each coil using 10mm socket (each bolt has a washer) Lift out coil taking note of cylinder number for each for reinstallation.
- Remove secondary air valve hose, pre-cat sensor cables and all electrical connectors from exhaust side which prevent valve cover removal.

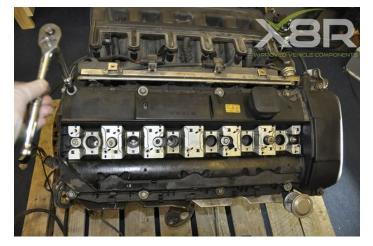
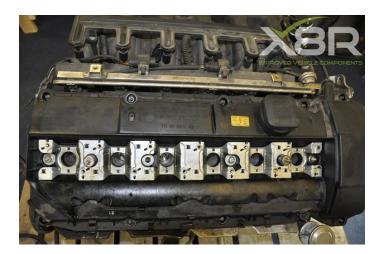
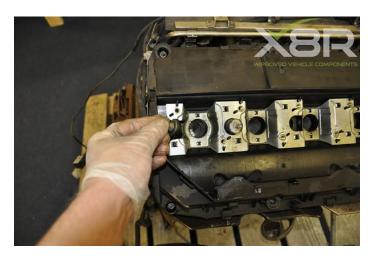
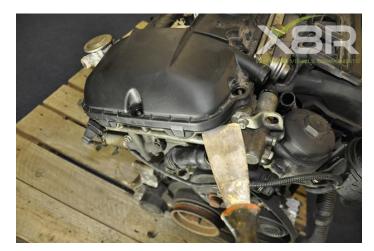
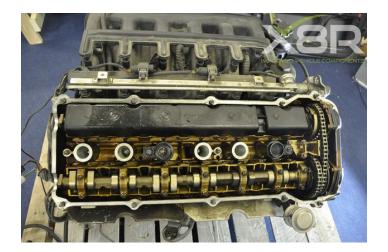
### Step 5: Remove valve cover

- Remove all 11x valve cover bolts using 10mm socket, each bolt has a grommet and washer make sure these are kept safe. Remove 4x central valve cover bolts using 10mm socket.
- Remove valve cover from engine. Insert a large blade or scraper between valve cover gasket and engine head and lever the cover gently loose, on the corner sections of the front of the valve cover RTV sealant will have been used to seal this section, using scraper lever between gasket and engine head to break sealant.

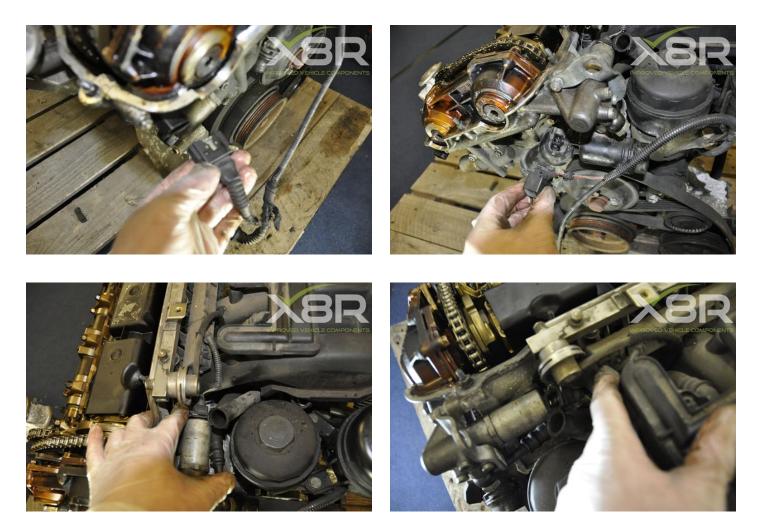
- Step 6: Remove vanos electrical connectors Remove camshaft position sensor and exhaust solenoid connectors, push in sides and wiggle loose
  - Remove intake solenoid connector and thermostat connector press in metal clips and lift off connectors.

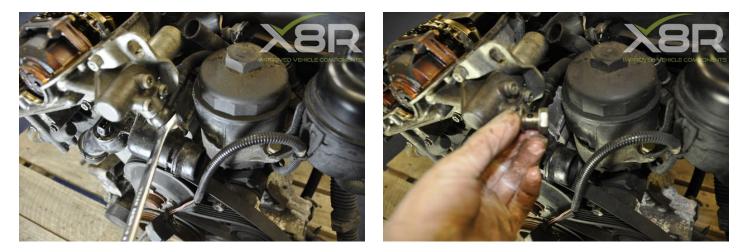
Step 7: Remove oil hose
Remove oil hose and bolt using 19mm spanner (image 8) retain the two washers (each side of the hose).

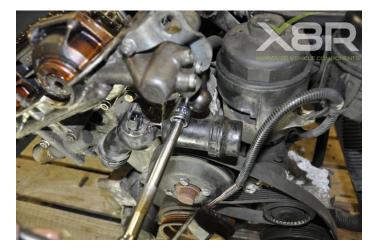
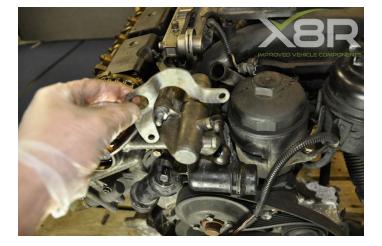
Step 8: Remove engine lift bracket • Remove engine lift bracket from Vanos unit using 11mm socket top bolt and 13mm socket bottom bolt. Rotate bracket bottom to top then remove

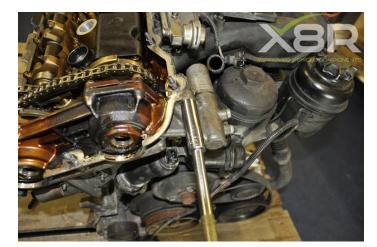
- Step 9: Remove vanos unit
  Remove x2 Vanos cylinder cover bolts using 8mm Alan key socket, oil will leak once bolts are removed have a container ready to catch oil, clean up any spills.
  - Remove x2 orange plastic Vanos piston caps with long nose pliers. Remove Vanos piston shaft bolts x2 using T30 Torx. IMPORTANT these bolts are Left hand thread, remove by unscrewing clockwise. These bolts are very • delicate unscrew the correct way with care. If the bolt does break continue with removal, the screw can be unthreaded later.
  - Remove 6x Vanos mounting bolts, on the lower front half of the Vanos unit using 10mm socket. Remove Vanos Right top mounting bolt with 13mm socket. Pull Vanos unit forwards and remove; make sure Vanos gasket is also removed from head. Take care to collect any spilling oil. Tilt Vanos unit in to container to remove all oil from unit.

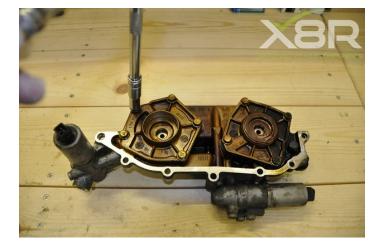
### Step 10: Remove vanos cover

- Position the Vanos unit on work bench as shown in image.
- Remove Vanos cover removing 9x 10mm bolts, right hand size as orientated has a spring behind the piston which will force the cover off as removing, press down on cylinder cover when removing to aid removal of bolts. Remove pistons and spring making note of which piston corresponds to which cylinder. Drain and clean away oil from pistons and cylinders.
- To diagnose Vanos failure you can slide the pistons in and out of their respective cylinder, you should notice a very loose fit. Inspect cylinders for any damage, they should be very smooth.

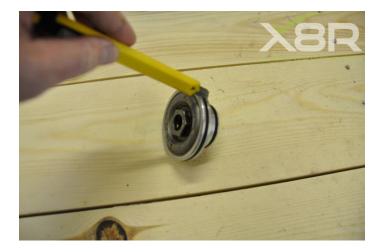
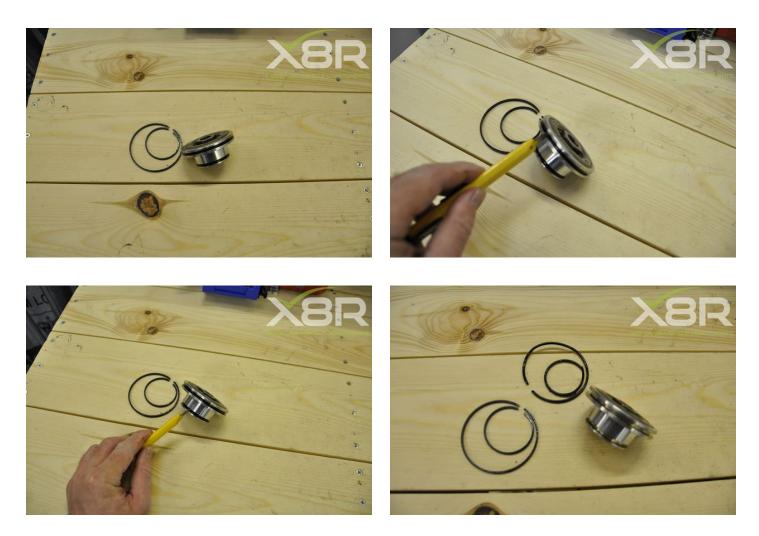
# Step 11: Remove vanos seals

Remove OEM seals from both pistons, each piston will have two grooves; in each groove will be 2 seals, 4 seals in total on each piston. Remove these carefully
using a sharp blade. Once removed the piston should have no seals or seal remnants in the piston, clean grooves. Take this complete stage slowly making sure
not to damage the piston.

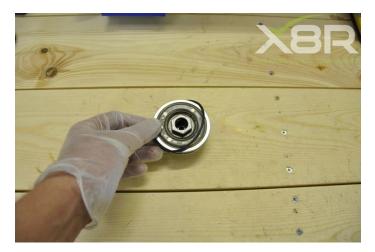
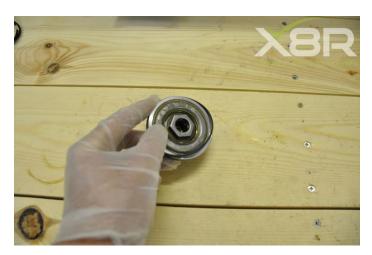
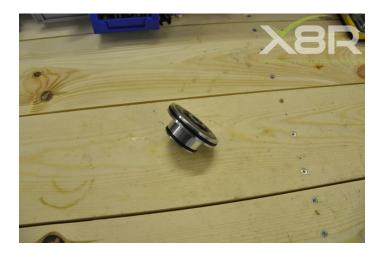
# Step 12: Install new seals

- Take a piston and install our large Viton o-ring in the bigger groove and our smaller Viton O-ring in the smaller groove, repeat this for the other piston. At this stage both pistons now have two 0-rings installed 1 big (top), 1 small (bottom). Make sure Orings are seated correctly and are not twisted.
- Take PTFE rings from our kit x2 big, x2 small and soak in warm water for 3 minutes, take out and dry. Stretch large PTFE ring over piston and in to large groove (top) this will take a little force, stretch evenly and take care not to bend or damage. Once in groove the ring should seat nicely twist the ring (it should move when twisting) within the groove and check that ring is seated correctly. Repeat process for smaller ring in bottom groove, replicate process with second piston.

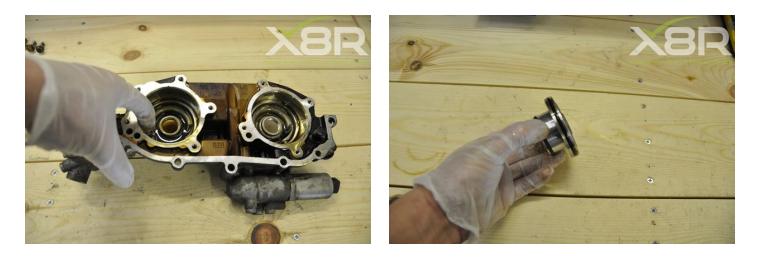
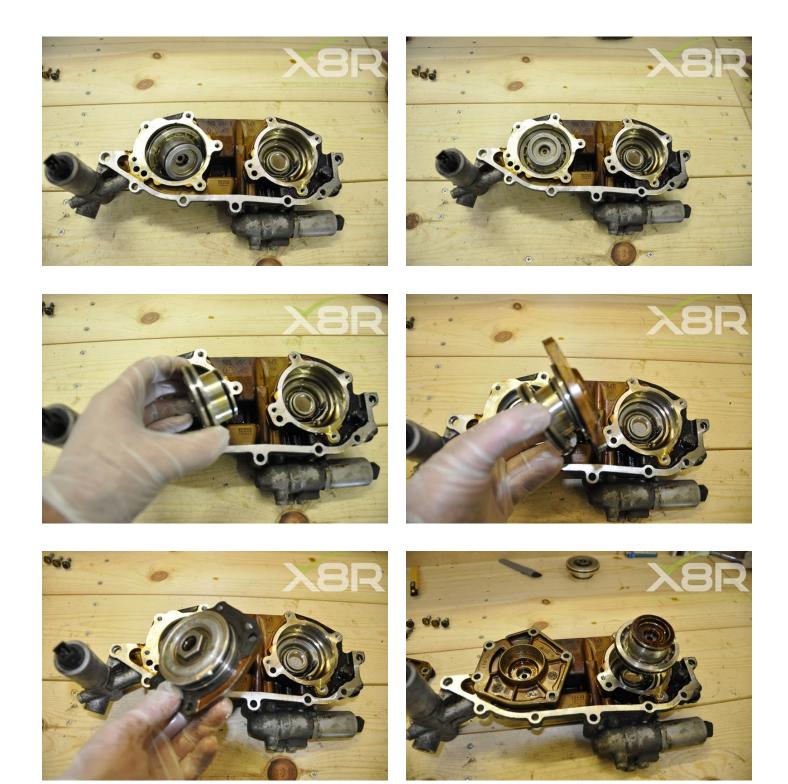
### Step 13: Resize seals

- The piston seals will now need resizing. Coat the inside of the left hand cylinder of the Vanos unit with engine oil, cover all of surface, coat left hand cylinder piston with oil making sure top larger seal has a good layer of oil, insert large end of piston in to left hand cylinder at a 60 degree angle then rotate piston to correct orientation, if seal binds keep removing and reinserting piston until piston ring resizes correctly. Insert piston fully in to cylinder and leave for 5 minutes so seals can resize correctly then remove.

- Apply layer of oil to left cylinder cover and to bottom seal of piston. Insert piston in to cylinder cover (gasket side) at an angle, rotate to correct orientation you will
  find some of seal protrudes preventing piston orientating correctly in cylinder, push in protruding seal and gently orientate until piston seats correctly. Insert piston
  fully in to cylinder cover and leave piston seal to reshape for 5 minutes.

- Repeat this process for the Right hand piston in the Right hand cylinder and cylinder cover.
- Re oil pistons and cylinders, install pistons fully in to correct side cylinder cover, insert piston spring Right hand side cylinder, refit cylinder covers with piston in situe. Tighten 9x bolts gently ensuring piston spring orientates correctly, carry out this process slowly, pressure will be needed on right hand cylinder to compress spring whilst tightening bolts. Bolts should be tightened to 10 Nm in a cross pattern. Check pistons have seated correctly by pushing in to cylinder this will require a little force. The Vanos unit can now be remounted to the vehicle.

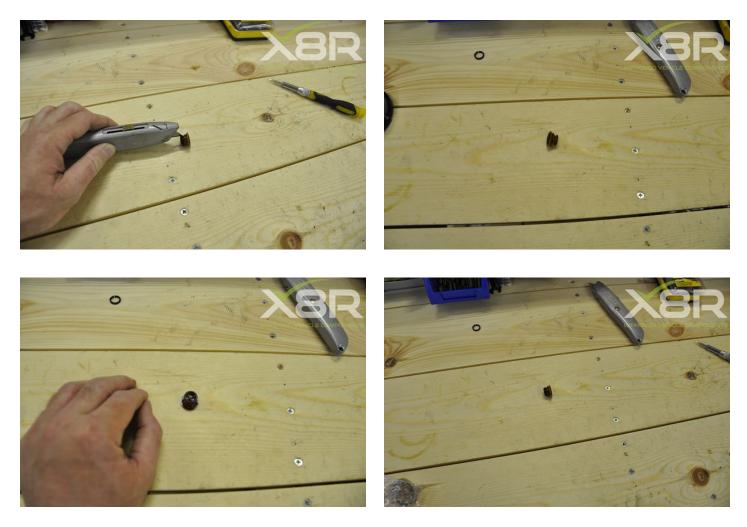
Step 14: Replace seals on Vanos piston caps
Cut old seals from x2 Vanos piston caps and replace with the 2 small seals from our kit.
